Auckland – Wharf Building Structural Monitoring

CLIENT: AUCKLAND TRANSPORT / CKL SURVEYS / POSITION PARTNERS

How remote monitoring safeguarded historic building during seawall repairs

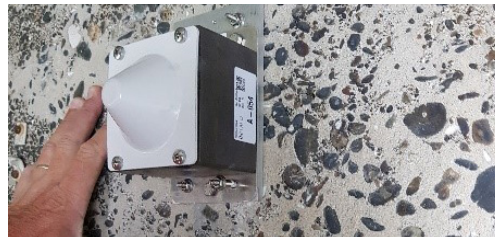
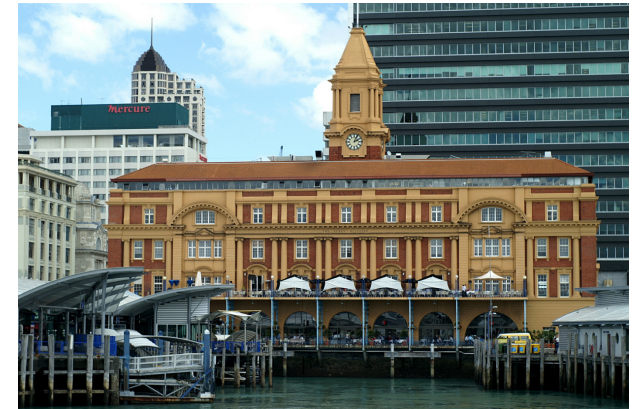
Position Partners installed a total of six high precision triaxial tilt sensors along the sea wall under the wharf. The mesh network formed by these wireless sensors relayed data to a secure cloud server via a solar-powered cellular gateway. Registered users of Senceive’s WebMonitor visualisation software could view and interact with the data.

Alert levels defined by Auckland Transport were assessed on an ongoing basis. These could be adjusted remotely so that any movement could be prioritised. The system provided the client with up-to-the minute data and the ability to change reporting rates and text alert trigger levels remotely - and the reassurance of knowing how the structure was behaving without leaving the office.

The robust IP66/68 rated enclosure with protective antenna cap made it ideal for the harsh saline environment, with the nodes appearing as good as new 18 months after installation. The long battery life (potentially 12-15 years) allowed for the monitoring programme to be extended without intervention or maintenance. This reduced risk to personnel and provided cost and labour savings to CKL compared to a methodology based on manual/optical monitoring.
